CHEMICAL PLANT OPERABLE UNIT REMEDIAL ACTION REPORT

WELDON SPRING SITE REMEDIAL ACTION PROJECT
WELDON SPRING, MISSOURI

JANUARY 2004

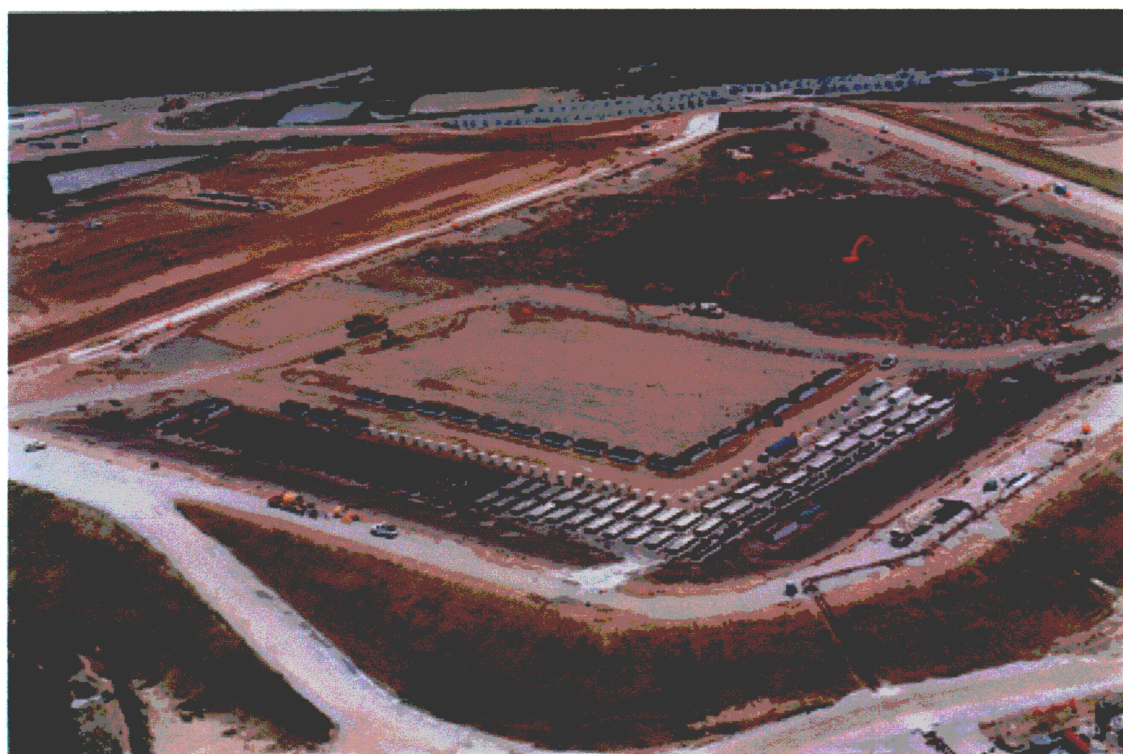
**GROUT PLACED TO FILL VOIDS IN CONTAINERIZED WASTE
MAY 1998**

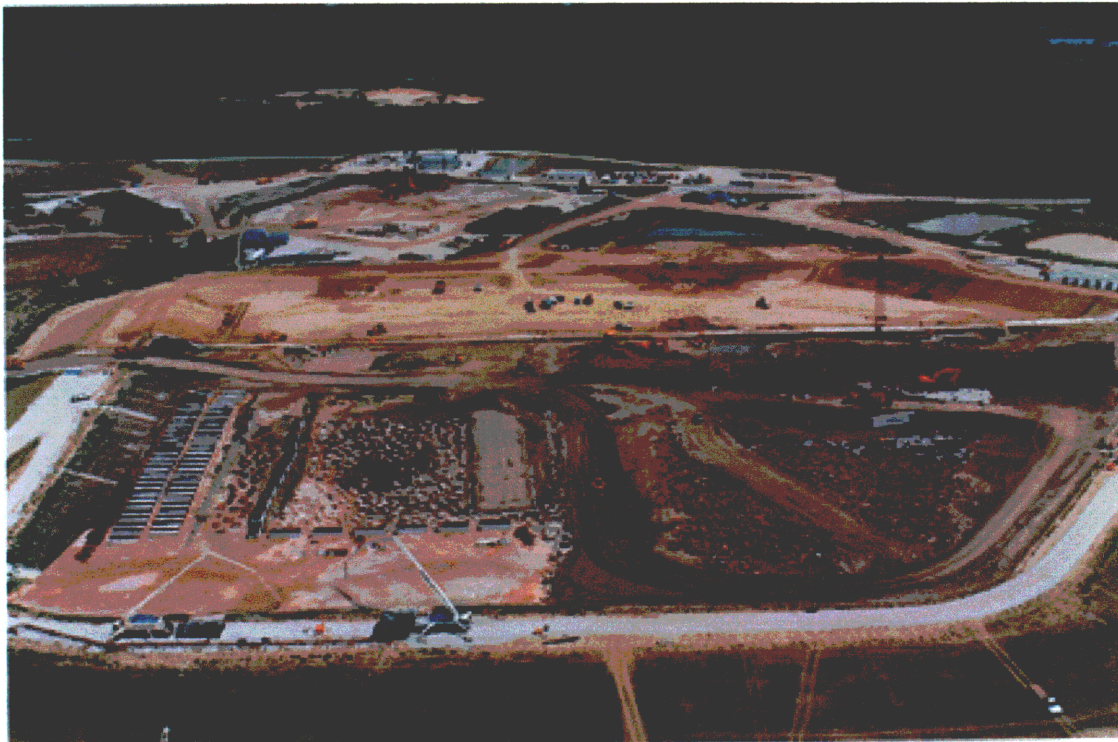
**CSS GROUT PLACEMENT AT LEFT, CRANE EMPTIES ACM, RIGHT
JULY 1998**

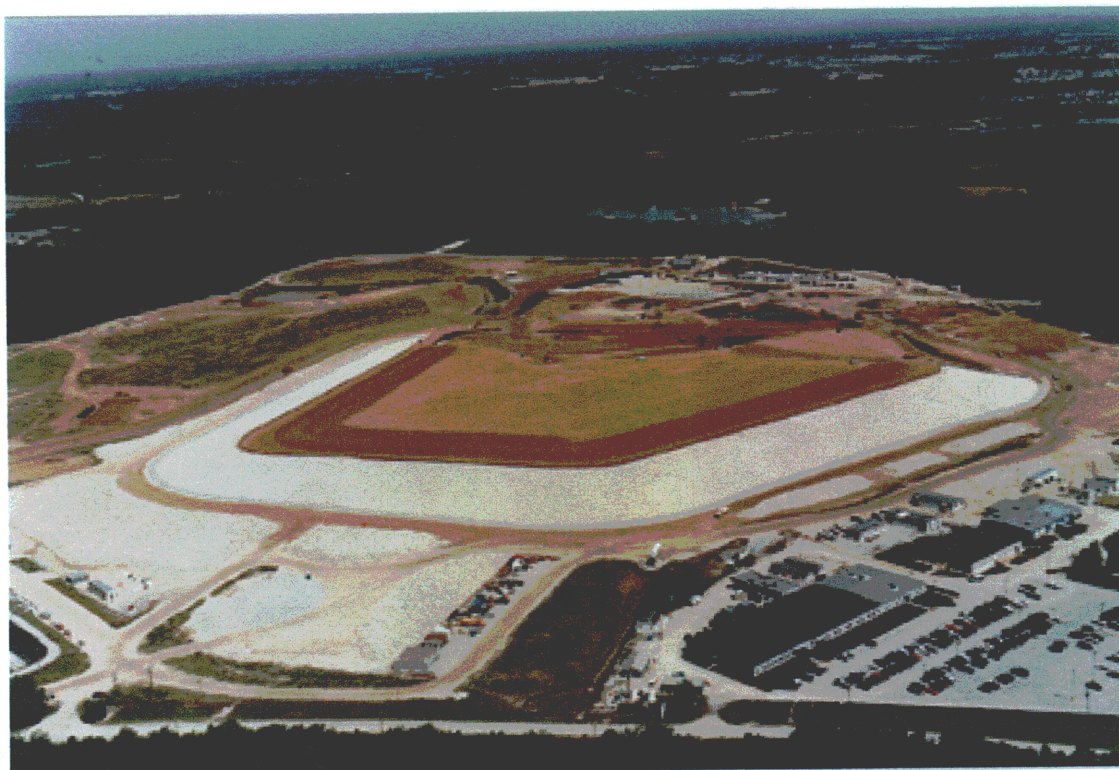
**DISPOSAL CELL SOUTH CAP RADON BARRIER PLACEMENT
MAY 2000**

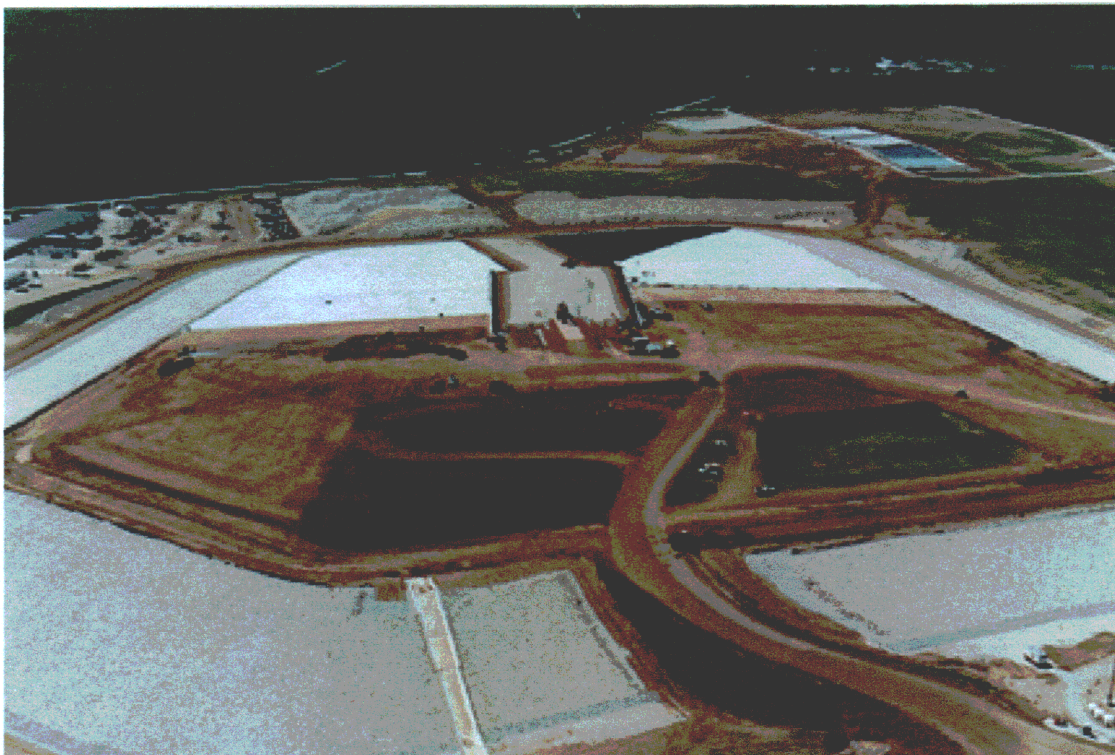
**RADON BARRIER PLACEMENT, TRIMMING & CAP LINERS
INSTALLATION - APRIL 2001**

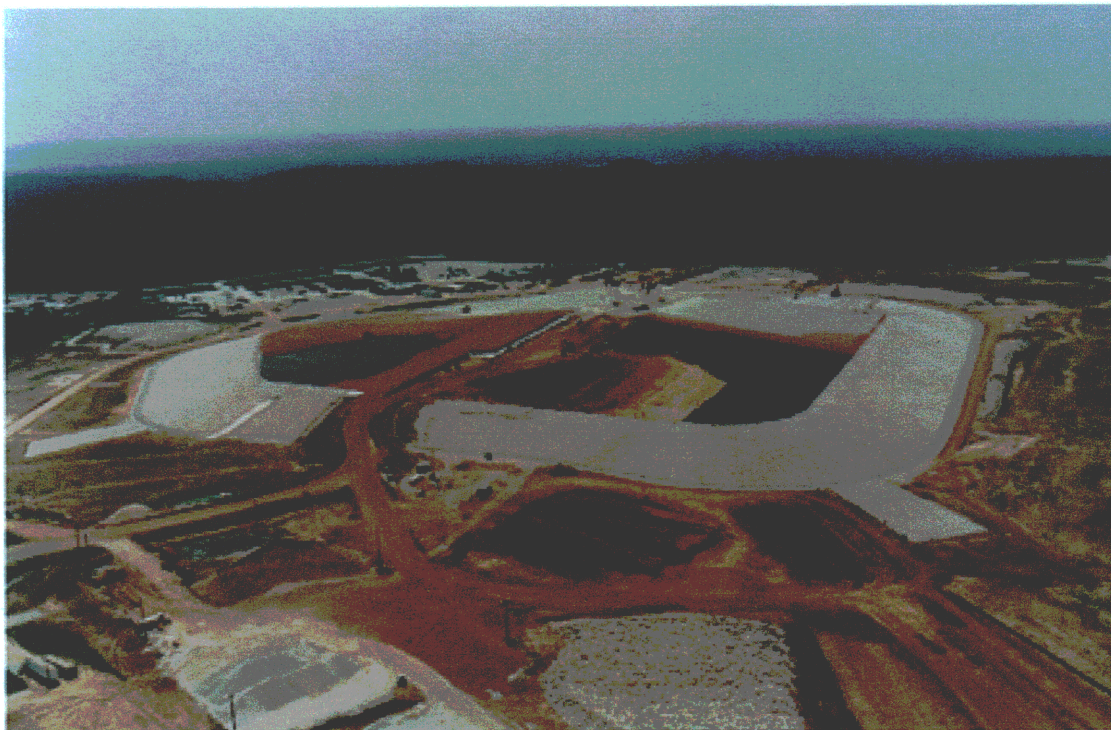
**CELL CAP RADON BARRIER, LINERS, DRAIN GRAVEL &
FILTER SAND PLACEMENTS - JUNE 2001**

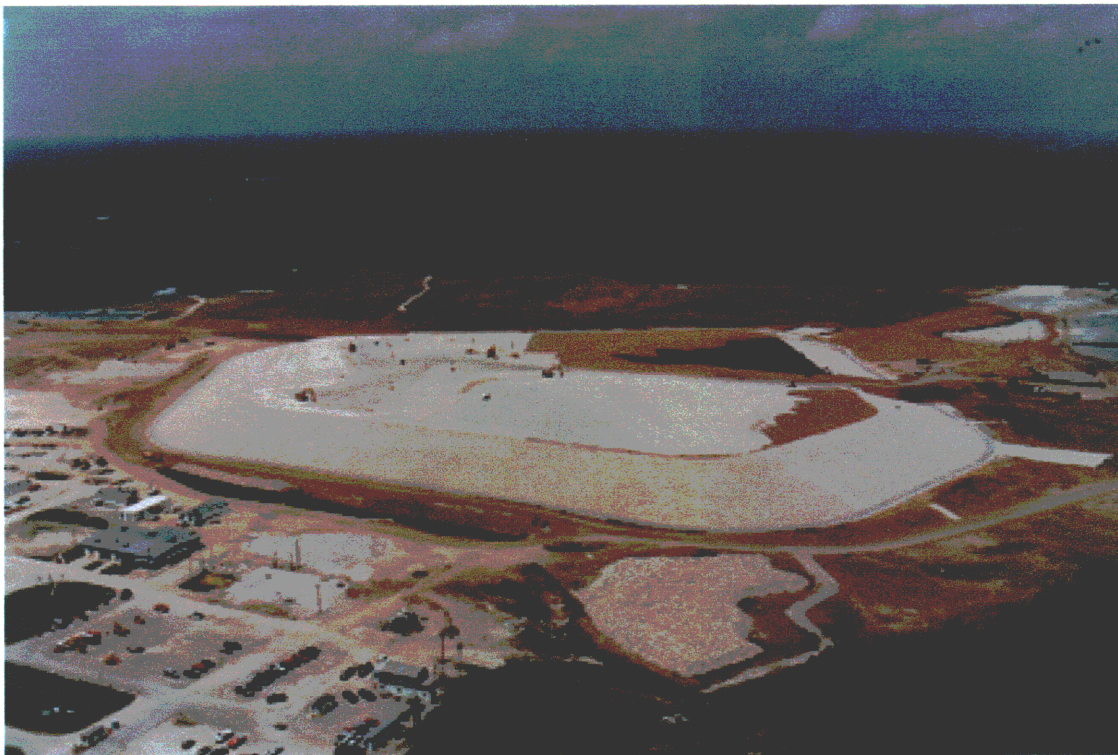
**CAP LINERS, DRAIN GRAVEL, FILTER SAND, BEDDING &
RIPRAP LAYERS SHOWN - JUNE 2001**

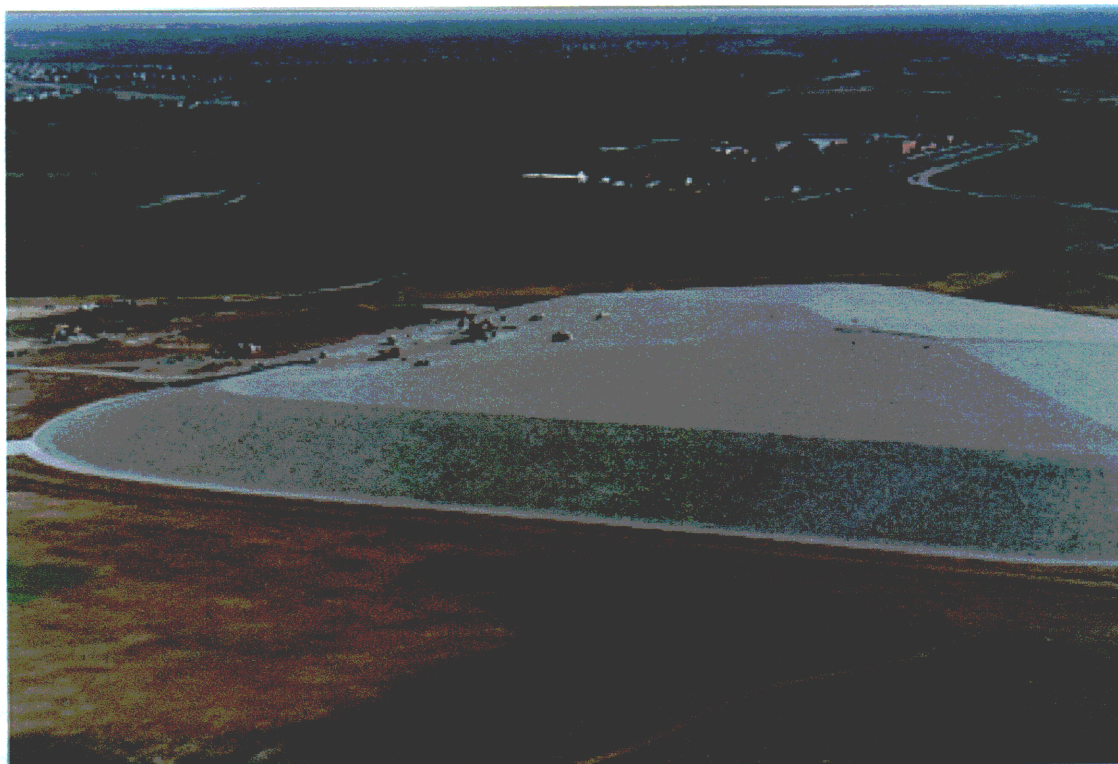
**RIPRAP PLACEMENT NEARING COMPLETION @ NORTH CAP
OCTOBER 2001**

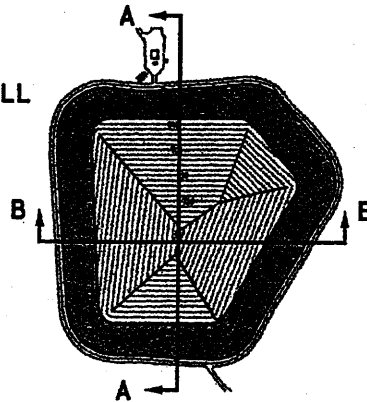
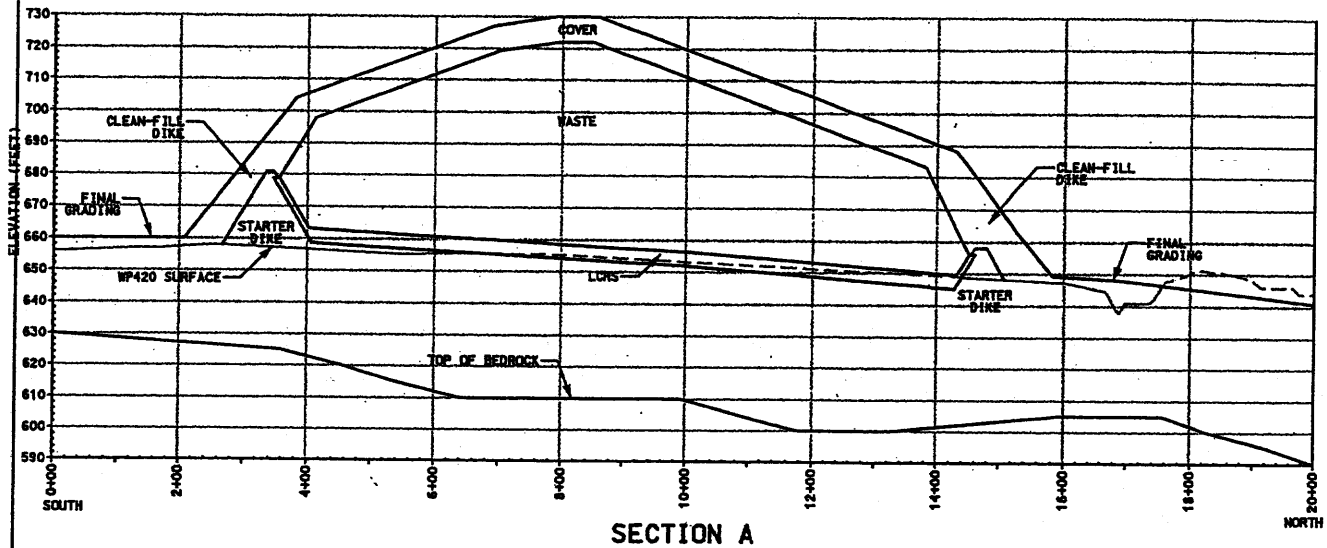
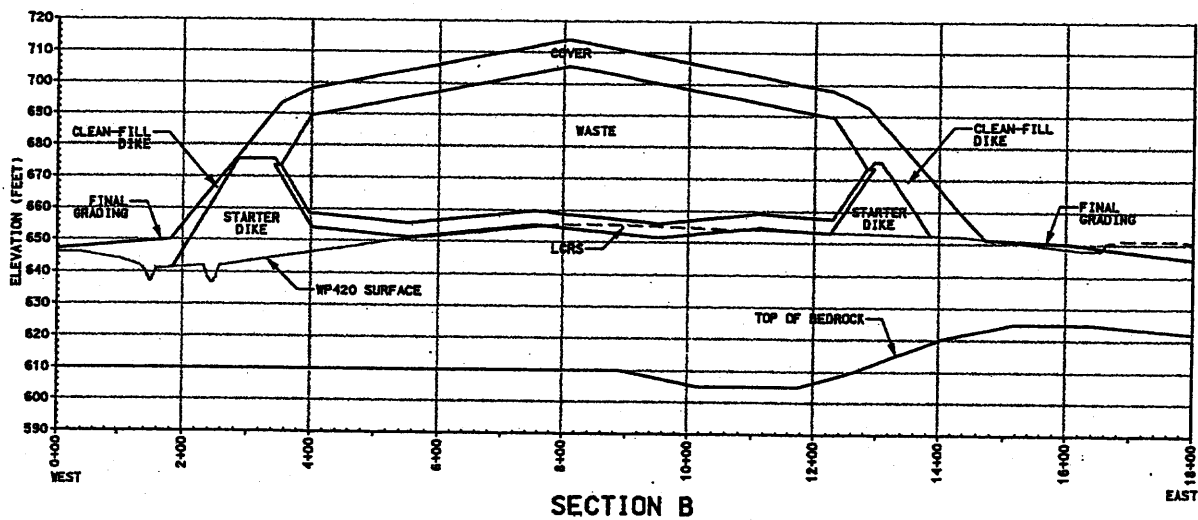
Regulations 10 CSR 25-7.264(2)(N)1.A requires 9m (30 ft) of soil or other material with a permeability of 1×10^{-7} cm/s or equivalent protection based on at least 6m (20 ft) of naturally occurring material for a landfill that receives only waste generated by its operator. As stated in the ROD, TSB testing, travel time and permittivity calculations were used to demonstrate that the soil units comprising the foundation of the disposal facility will provide a level of protection superior to the State requirement. Figure 5-5 shows the top of bedrock and the base of the disposal cell along with cross sections through the cell and foundation. The 20 ft requirement was met in all locations beneath the cell.

DISPOSAL CELL SECTIONS
